**Town Of Darien Department of Public Works Garage Complex:
Feasibility Study & Preliminary Concept Design
126 Ledge Road
Darien, CT. 06820**

Draft Study: November 4, 2015
Final Study: January 22, 2016

Silver/Petrucci + Associates, Inc.
Architects / Engineers / Interior Designers
3190 Whitney Avenue
Hamden, CT 06518
(203) 230-9007

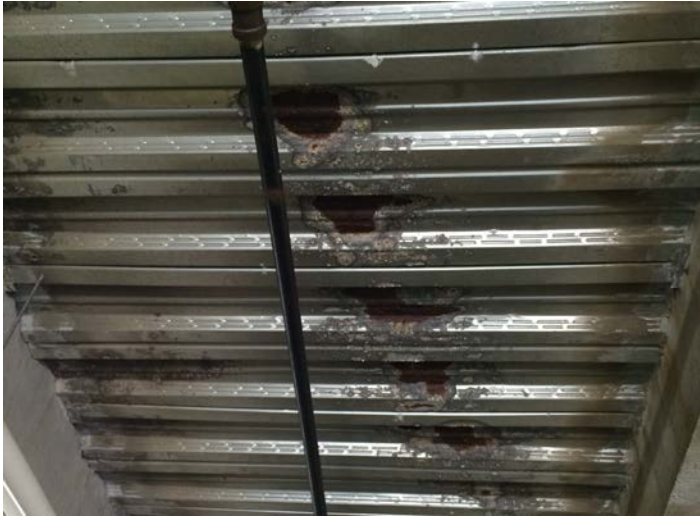
This area was not inspected by our staff. Photographs were provided to our office of this area which displayed a cast in place slab over a metal deck. Areas of the deck are observed to be corroded and will require repairs.

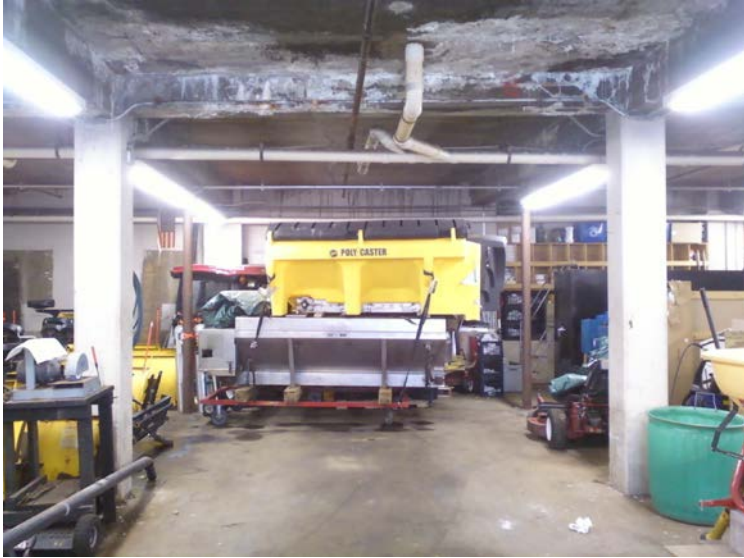
Photograph Exhibit "A"

Based on our visual observations during our site visit on October 14, 2015 the existing supported floor construction is understood to consist of a 6" reinforced cast in place concrete slab supported on cast in place concrete beams and cast in place concrete columns. The concrete has been repaired in various areas due to spalling resulting from the leaching of chemicals thru the slab surface. Please refer to Photograph Exhibits "A" thru "C".

All loose concrete must be removed from all surfaces (vertical and horizontal) and inspected to determine the extent of the damage before final recommendations can be provided. It is our understanding that concrete cores were previously taken in multiple areas for chemical analysis. We have requested copies of the reports as well as the samples if available to assist in our investigation.

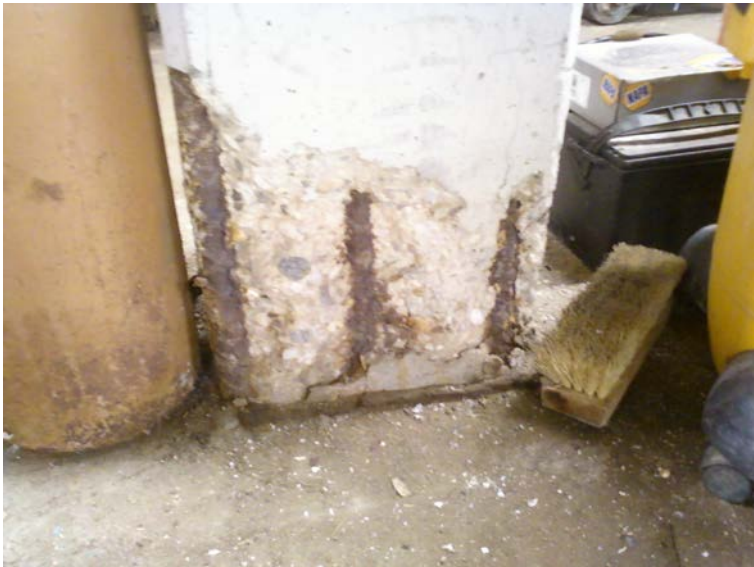
Photograph Exhibit "D"

The spalling of the concrete at the base of the columns has exposed the reinforcing. Please refer to Photograph Exhibit "D". These columns will require structural repairs.

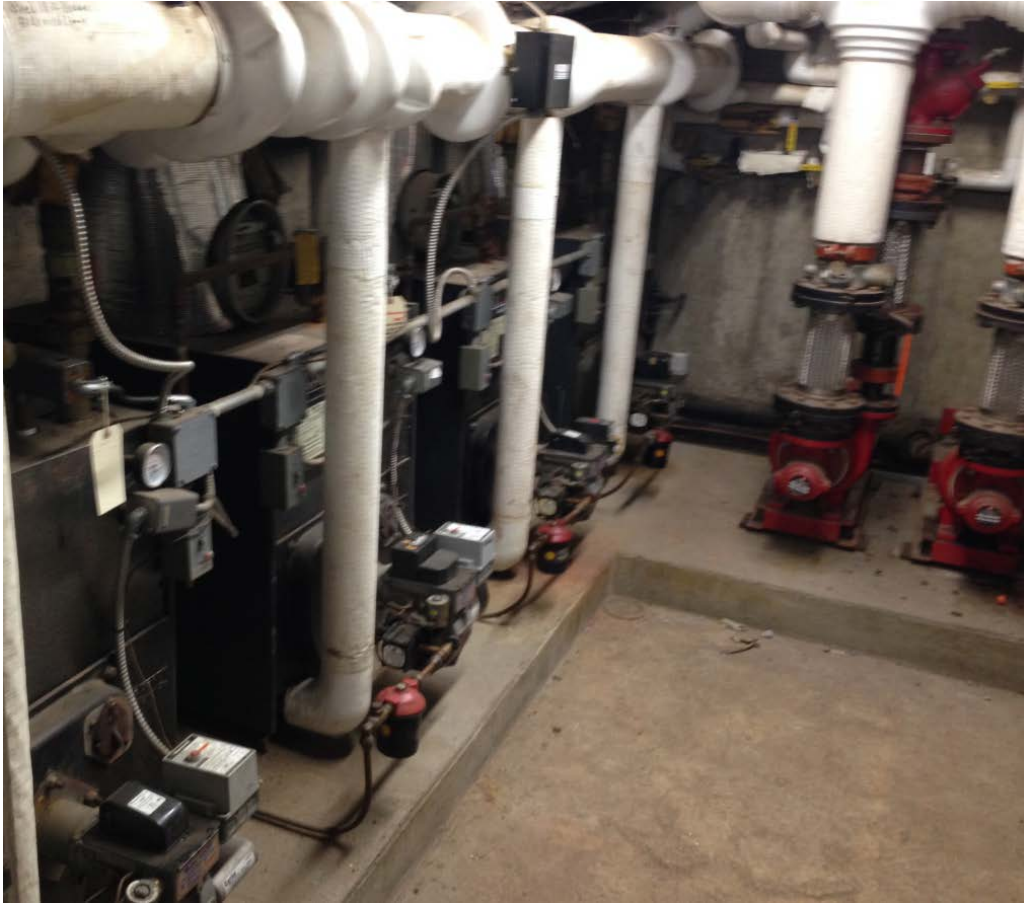
The facility is served by a Central Hot Water Plant consisting of four Slant Fin model L 70 C Modular Boilers firing No. 2 Fuel Oil with a gross heating output of approximately 1,340,000 BTU/Hr. Two base mounted Hot Water Pumps circulate hot water to Terminal Heating Equipment throughout the facility. Heating Terminal Equipment consists of Hot Water Unit Heaters serving the repair and storage bays, with Convectors and Finned Tube Radiation serving offices and common areas. The Boilers were installed in 1994 and are approaching their end of useful life. The Boiler Room is located on the lower level which is potentially subject to flooding.

It is expected the Gas Utility Company will provide a new gas service to the facility and it is therefore recommended that the oil fired boilers be removed and replaced with new gas fired heating equipment. Due to the potential for flooding on the lower level it is recommended that the existing Central Boiler Plant be dismantled and the space used for another purpose. In order to conserve valuable upper level floor space and reduce installation costs, it is recommended that new gas fired Terminal Heating Equipment be used, eliminating the need for a Boiler Plant.

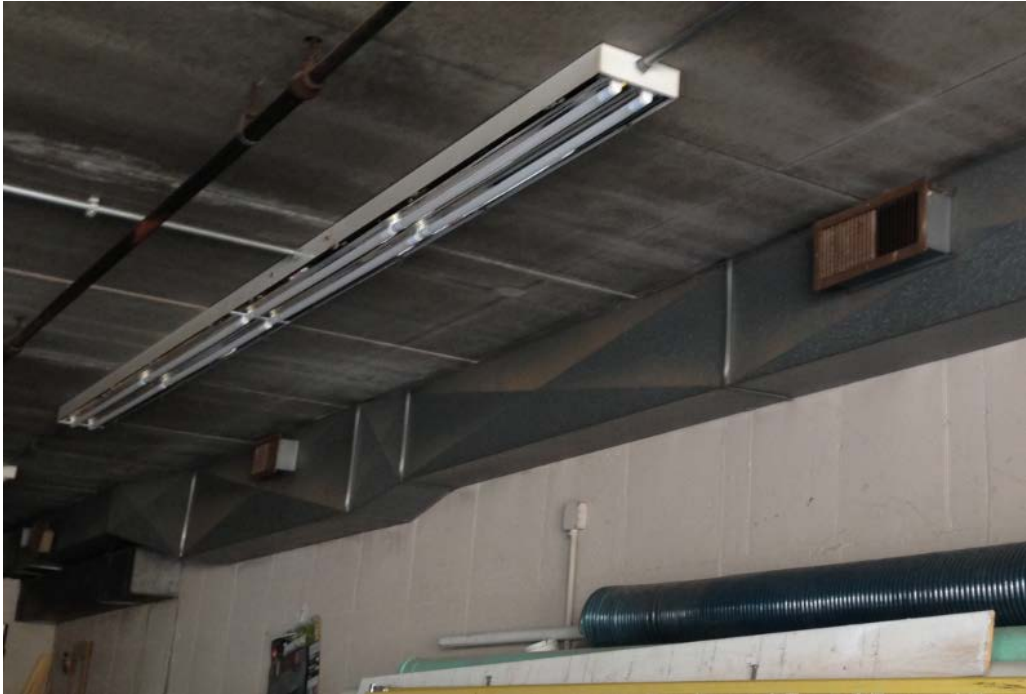
Exhaust Duct

Exhaust systems serving the Repair Bays are not code compliant and are at the end of their useful life. Most systems appear to be inoperable and there are damaged and missing sections

of exhaust duct. Exhaust quantities indicated in the 1993 Construction Documents are generally less than 1.0 CFM/SF. Current Code requires the ventilation system be capable of 1.5 CFM/SF for Repair and Storage Garages that exceed 850 SF in floor area.

The required ventilation rates for the Repair and Storage Bays is 0.05 CFM/SF (minimum) increasing to 1.5 CFM/SF upon detection of hazardous gasses. Due to the deficiencies of the existing systems, it is recommended that they be upgraded to provide the required ventilation rates for compliance with the Building Code. A Gas Detection System (CO, NO₂ and flammable vapors) will be required for control of Exhaust Systems, so ventilation rates may be reduced to minimum CFM during normal operation, when hazardous gasses and vapors are not present. Exhaust inlets in the repair bays will be located near the floor to prevent accumulation of flammable vapors. Make-up air will be provided through the overhead doors or through wall louvers with motorized dampers. Overhead doors and/or motorized dampers will have a control interlock with the Gas Detection System and will be zoned such that only the doors or dampers in the affected area will be opened. The exhaust system will also be equipped with manual switching to allow maximum ventilation when desired.

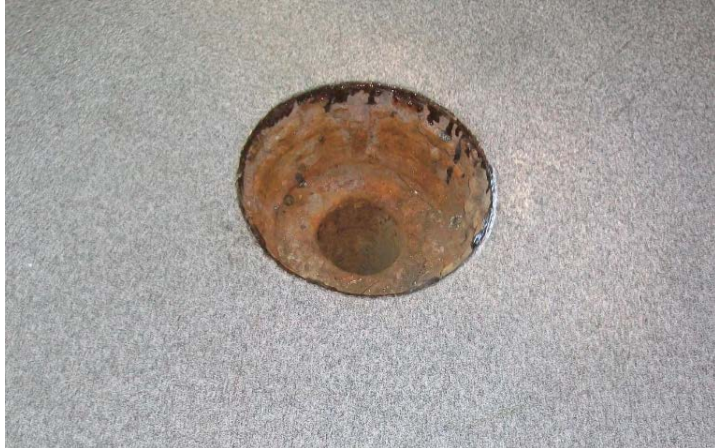
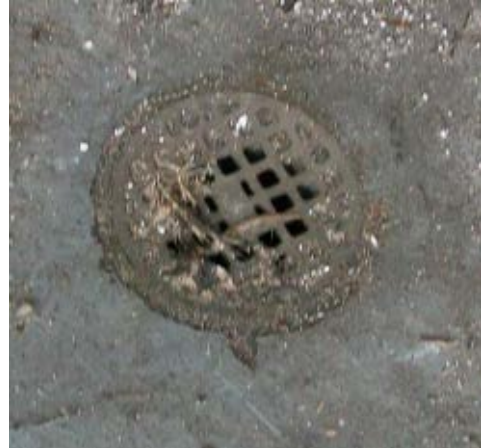
Several garage floor drains were observed to be clogged with sand and debris, while other floor drains were missing their grates. The condition of floor drain piping varied but some locations show sign of corrosion and leakage.

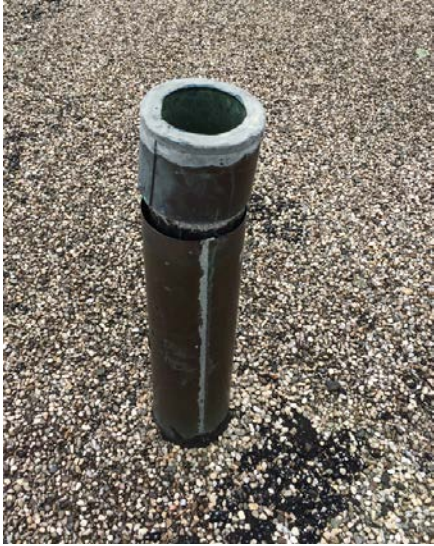
Plumbing vent termination through the roof is damaged and should be repaired accordingly to eliminate water infiltration.

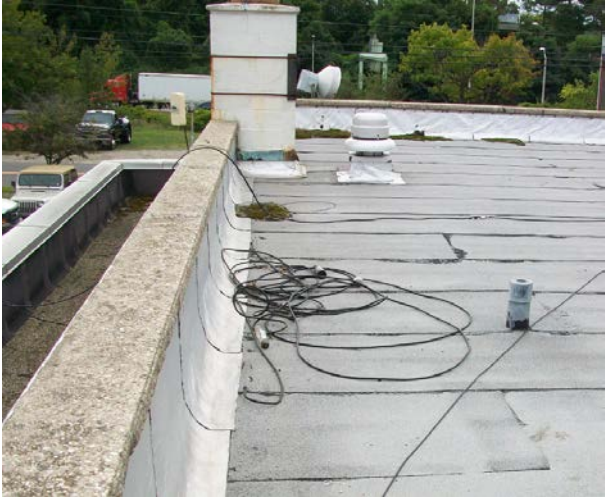
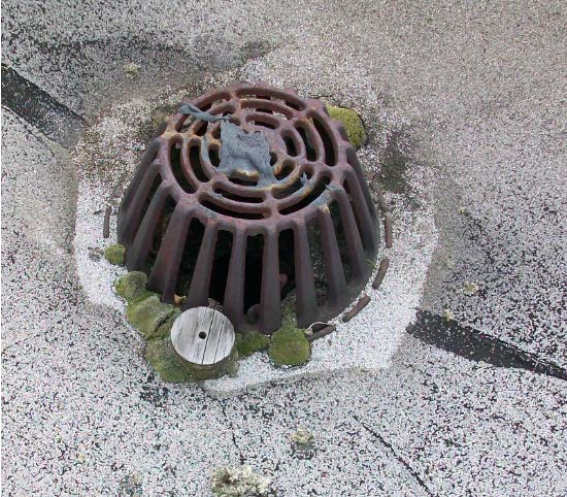
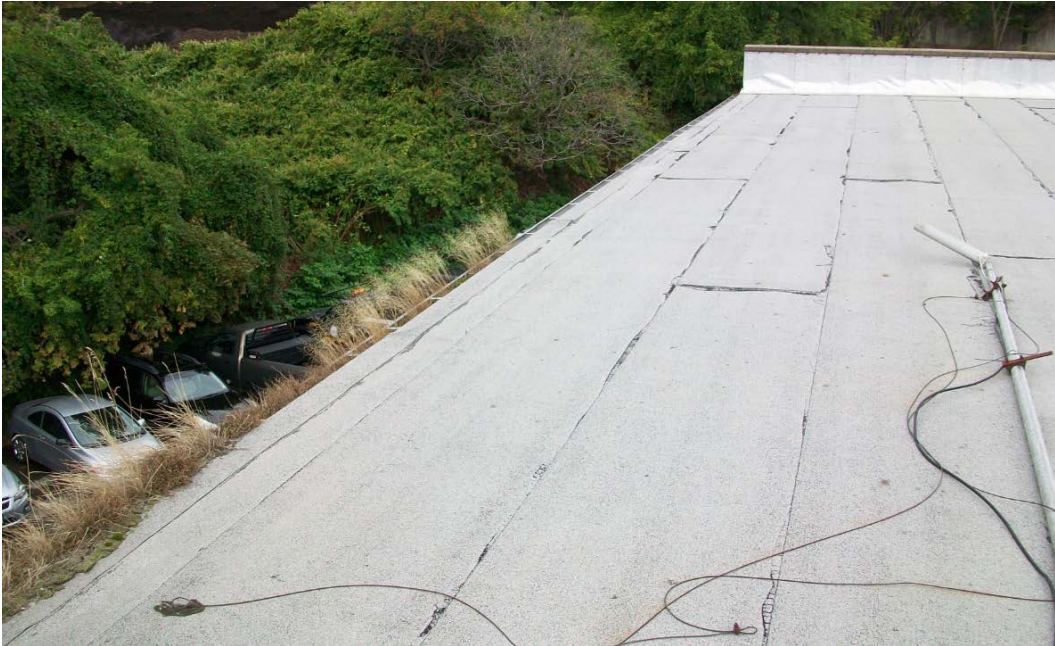
Minor ponding was observed in multiple locations throughout the roof and gutters were observed to be obstructed with vegetation growth.

Provide emergency or secondary roof drainage accommodations per the 2003 International Plumbing Code such as scuppers or piped overflow drains which discharge to grade accordingly to an approved location. Clean and snake roof drains, piping, gutters and leaders so they are clean and free of debris to allow proper drainage. Secure debris grates to roof drains to ensure proper operation.

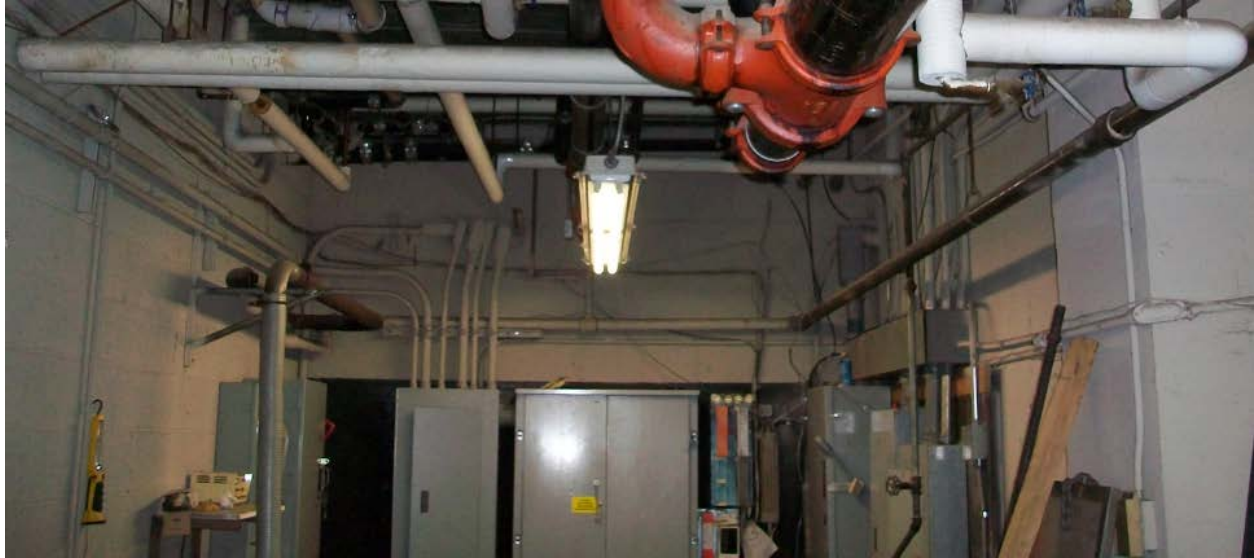
The systems drain line is currently routed high over electrical panels in numerous locations in the lower level. Further investigation is required to determine if additional locations are present.

In areas where freezing is not a concern, an automatic wet sprinkler system will be provided, all existing piping can remain Sch. 10 & 40 black steel contingent upon testing. Sample the existing to remain portions of the system in accordance with NFPA 25 (by a recognized testing laboratory acceptable to the authority having jurisdiction for field service testing) to determine the extent of any corrosion if any, and replace piping as necessary.

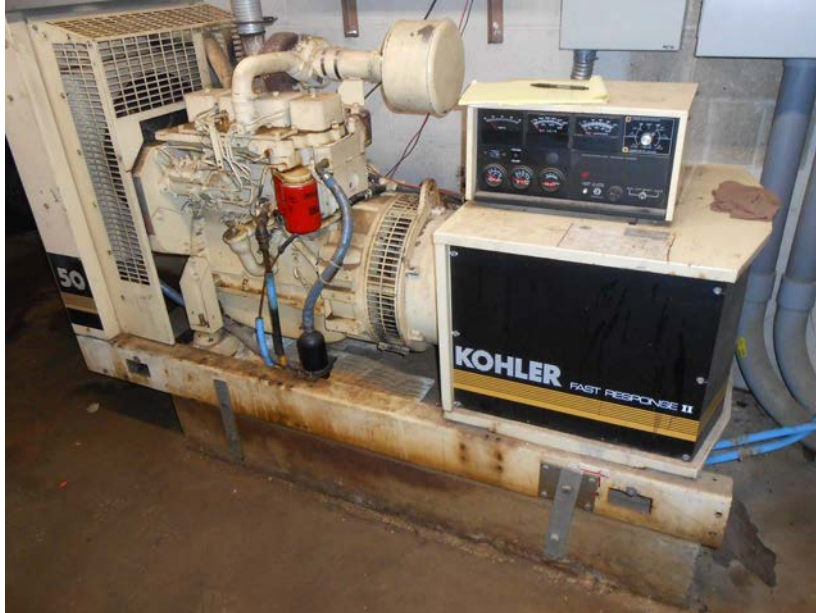
The facility currently contains a 3 phase 50KW diesel Kohler Fast Response II generator. This generator is of medium age and is rusting a little. The generator will be evaluated based on the new load that is being added to the building whether or not an increase in size is necessary.

With the addition of natural gas to the facility a new natural gas generator will be utilized. Since there will be a new gas service to the building the best spot to relocate the generator would be at a higher elevation as close as possible to the new gas line. This would mean removing the existing diesel generator, the existing transfer switch and extending any conduit and cable to the new location for the generator. A new Automatic Transfer Switch will be used to replace the existing Manual Transfer Switch. This switch will be placed in the same spot if it can fit, if it can't fit it will need to be placed as close as possible to the MDS & MDP to limit the length of cable needed. With the generator being moved outside a new location will need to be chosen so that any cable being run to the generator isn't too long so as to prevent a voltage drop. The areas to be electrified during use would remain as whatever areas are currently being electrified along with the new additions specifically the office area. All of the new offices, meeting/break room, bunk room, mechanics bay & wash bay would need to be added to the generators circuits to be electrified during use.

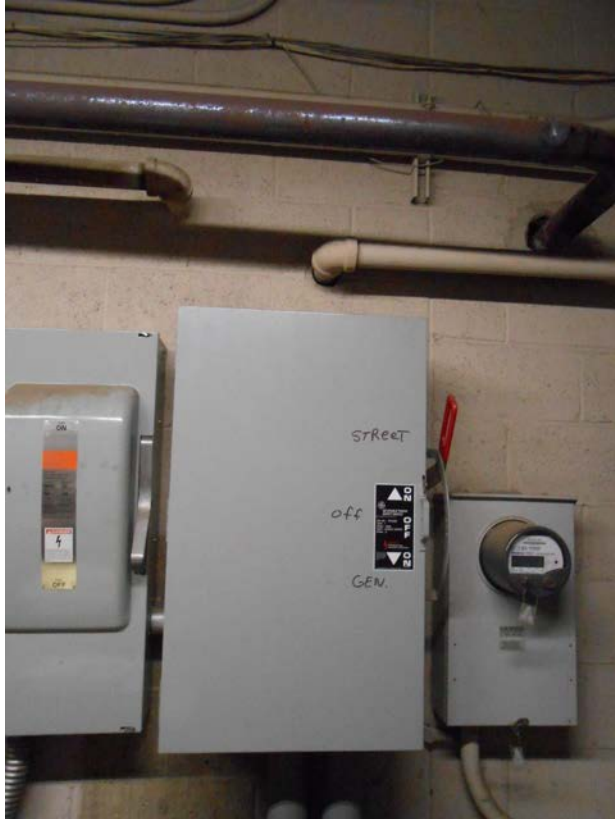
There is piping above the generator transfer switch & also above the panels in the generator room which are in violation of NEC code 110.26(E)(1)(a). This code states that all panelboards & switchboards need dedicated equipment space which is located 6' above the electrical equipment. Since the piping is already there it could either be rerouted somewhere so that it isn't in the dedicated space anymore, or a drip tray can be installed so that no condensation or liquid drips onto the electrical equipment.

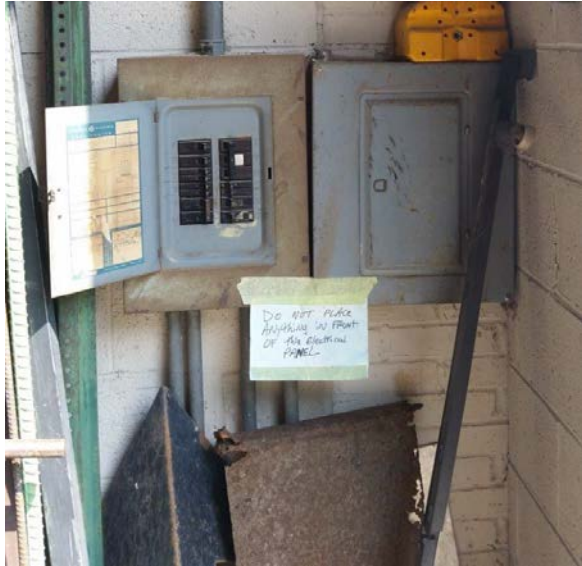
All of the panels not including the 2 panels that are rusted and not being used are in good shape and have plenty of spares. The 2 rusted panels that aren't being used anymore will be removed completely. It should be confirmed prior to removal if the circuits for these panels being removed are still in place and abandoned, or if they have been removed already. Any new circuits added to the facility will have plenty of power from any of the panels. Power will need to be provided for any new infrastructure that will be added.

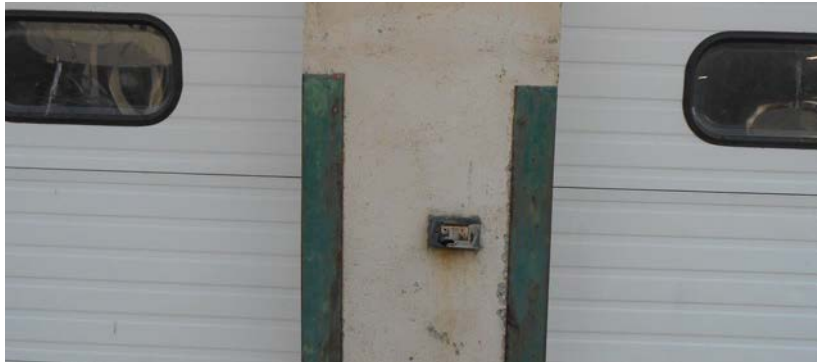
There are existing 110/220V receptacles throughout the entire facility which for the most part appear to be in good shape. Some receptacles are missing cover plates for them specifically the receptacles that are just outside of the garage bays on the lower levels. There are multiple junction boxes throughout the garage bays which are missing cover plates.

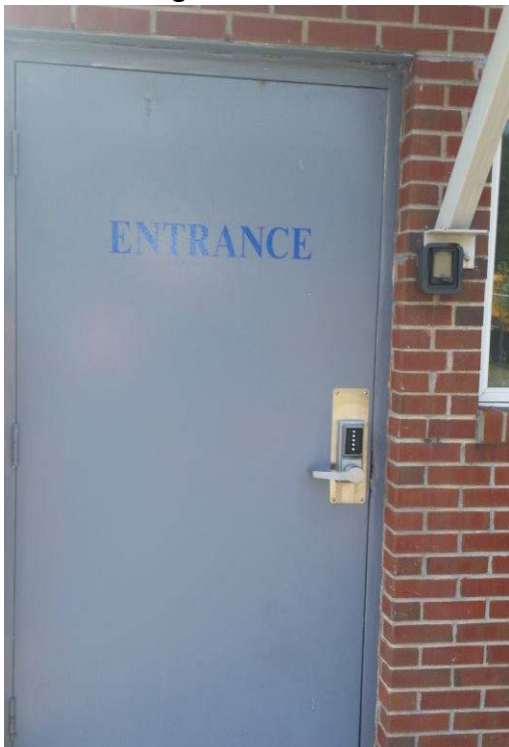
There are minimal means of security for the facility with the entrance having a keypad on it. There are several cameras in the facility for the Board of Education but not for the Department of Public Works. The garage bay doors appear to be open during the warm weather so it would be easy for any random person to just walk into the facility without needing any kind of clearance to get in.

There will be a new keypad/card reader added to the facility so that only employees can enter & any visitors will have to go to the lobby to deliver packages or to be let into the facility. There will also be cameras added around the exterior of the building & inside the building to. Specific locations of the cameras will be discussed during the design phase of the project. There might be a need to upgrade the current system to hold more cameras depending on the amount of cameras that will be added to the system. There will also be intrusion detection set up as a part of the new security system.
