**Town Of Darien Department of Public Works Garage Complex:
Feasibility Study & Preliminary Concept Design
126 Ledge Road
Darien, CT. 06820**

Draft Study: November 4, 2015
Final Study: January 22, 2016

Silver/Petrucci + Associates, Inc.
Architects / Engineers / Interior Designers
3190 Whitney Avenue
Hamden, CT 06518
(203) 230-9007

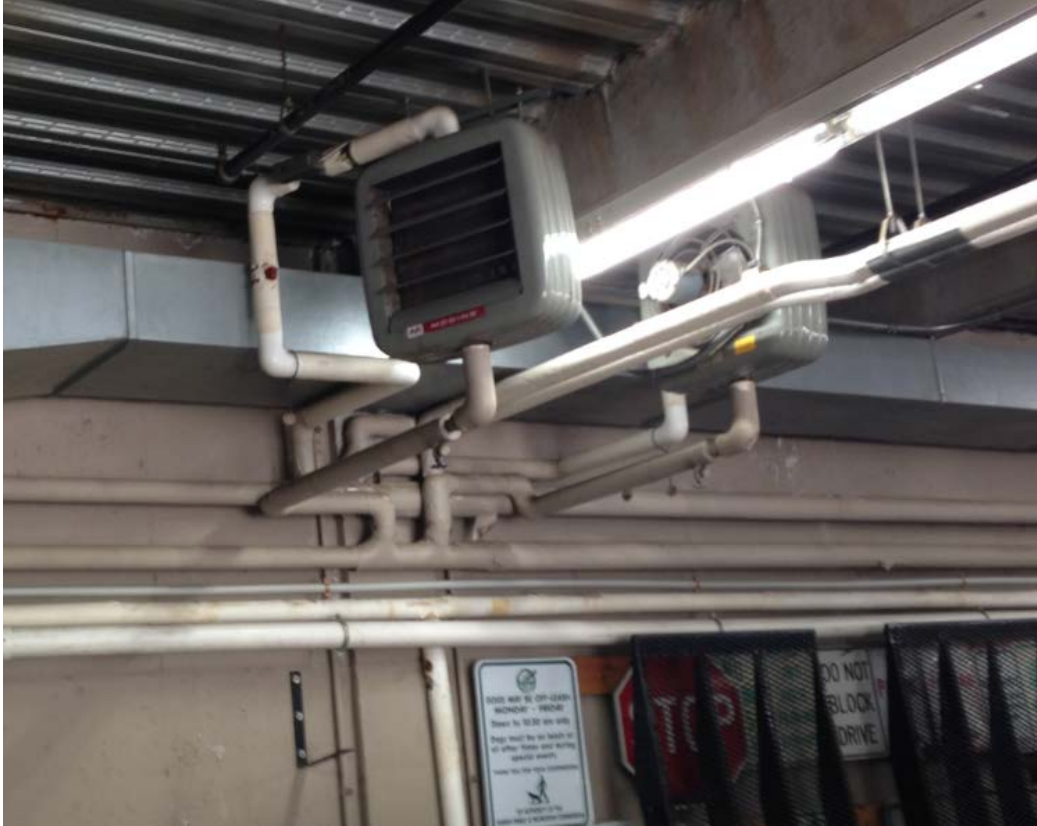
Typical Hot Water Unit Heaters

The facility is served by a Central Hot Water Plant consisting of four Slant Fin model L 70 C Modular Boilers firing No. 2 Fuel Oil with a gross heating output of approximately 1,340,000 BTU/Hr. Two base mounted Hot Water Pumps circulate hot water to Terminal Heating Equipment throughout the facility. Heating Terminal Equipment consists of Hot Water Unit Heaters serving the repair and storage bays, with Convectors and Finned Tube Radiation serving offices and common areas. The Boilers were installed in 1994 and are approaching their end of useful life. The Boiler Room is located on the lower level which is potentially subject to flooding.

It is expected the Gas Utility Company will provide a new gas service to the facility and it is therefore recommended that the oil fired boilers be removed and replaced with new gas fired heating equipment. Due to the potential for flooding on the lower level it is recommended that the existing Central Boiler Plant be dismantled and the space used for another purpose. In order to conserve valuable upper level floor space and reduce installation costs, it is recommended that new gas fired Terminal Heating Equipment be used, eliminating the need for a Boiler Plant.

Existing Boilers, Pumps and associated piping and Terminal Heating Equipment will be removed. The Storage and Repair Bays will be served by natural gas fired Unit Heaters. High Efficiency Condensing Unit Heaters, with combustion efficiencies exceeding 95%, may be used in spaces that will be maintained above 40°F. By comparison, standard efficiency Unit Heaters are typically 80% efficient. Improved operating efficiency will also be achieved with gas fired Unit Heaters by eliminating the pump energy required to circulate hot water continuously during the heating season. Condensing appliances will require a condensate drainage system, equipped with acid neutralization device consisting of a PVC tube containing a limestone medium.

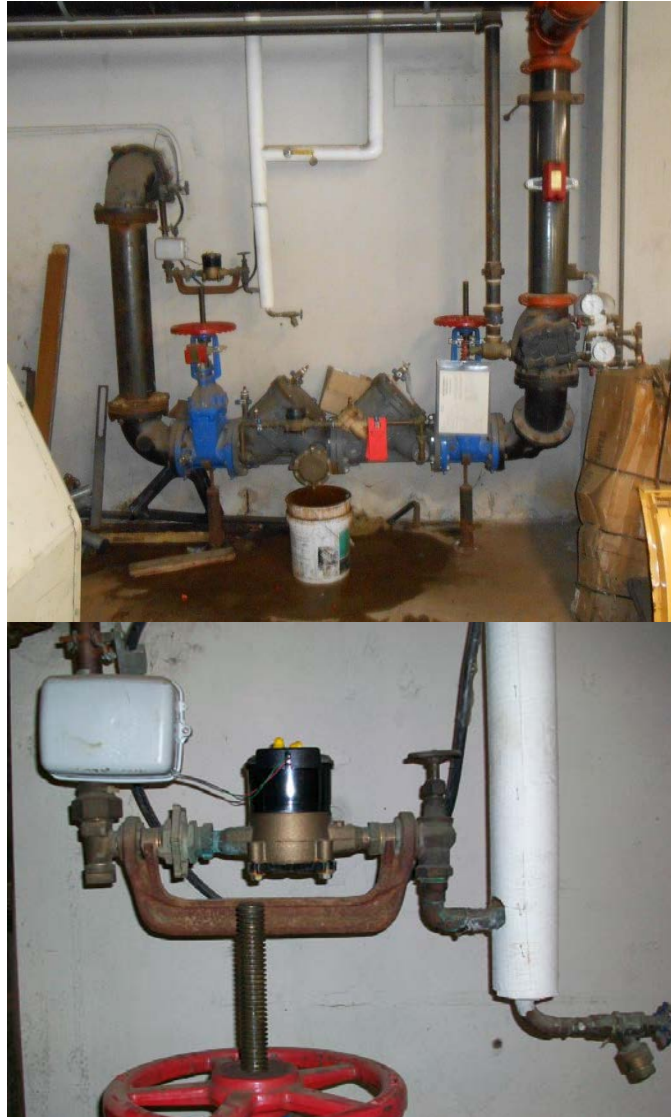
The facility is provided with a 1" domestic water service supplied from the Aquarion Water Co. The static water pressure ranges from 75 PSI to 90 PSI (pressure indicated on the fire protection riser inspection tag) which is adequate to serve the facility's water demand. The domestic service consists of a water meter and copper piping with soldered joints and fittings. The service enters the building on the lower level parallel to the fire protection water service. An angle valve is provided as means of system shut down within the building and is located on the outlet of the water meter. The water service main is not provided with adequate supports and was observed swaying and moving due to pressure fluctuations from domestic usage which could result in eventual piping damage. The 1" cold water service is then distributed throughout the facility to all plumbing fixtures and to the water heater. The service appears to be in good condition, though working condition of the main shut off valve is unknown. A cross connection device to protect the municipal water system was not observed on building's water service. A double check backflow preventer was installed on the domestic water feed to the boiler system. A variety of domestic water piping materials have been installed which consist of wrought copper piping with soldered and fittings, mechanical press type copper joints and fittings, and reinforced PEX tubing with metal shield and crimped fittings. Some piping was provided with mineral fiber insulation with PVC elbows, others partially with flexible elastomeric insulation.

Vehicle wash down takes place on site with water supplied not from the building, but from a local fire hydrant. The current domestic water provisions are not adequate in terms of flow for the facilities wash down operations.

The anticipated demand of the facility will be increasing due to DPW programming which includes a new wash bay and increased plumbing fixture count with commercial grade fixtures. It is recommended to increase the water service size to meet the building's new water demands because the current 1" service can only flow approximately 15 gpm while still remaining at or below the recommended velocity of 5 feet per second (per the CDA's Copper Tube Hand book).

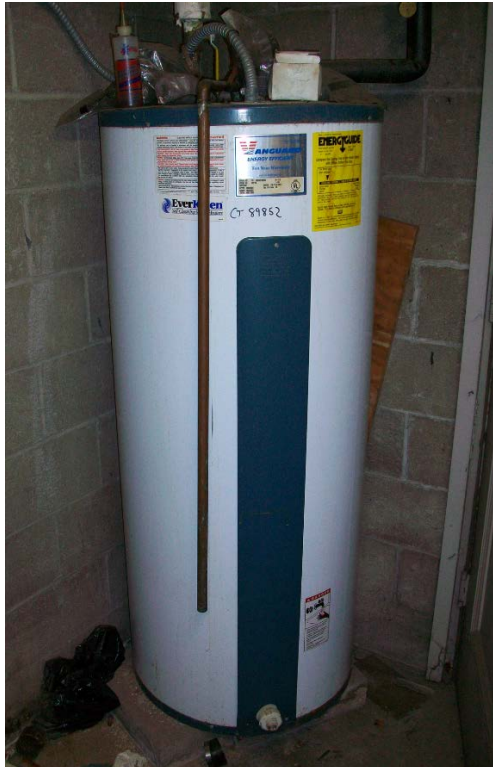
The facility generates domestic hot water via 80 gallon electric storage type water heater. The hot water distribution system is not equipped with a hot water recirculation piping loop, circulator pump, nor thermostatic mixing valve. The equipment appears to be in fair operating condition but is nearing its life expectancy and out of warranty.

The average life expectancy for an electric water varies but is around 15 years. Given the age of the facility it is recommended to provide a new water heating system to deliver 120°F hot water to all plumbing fixtures.

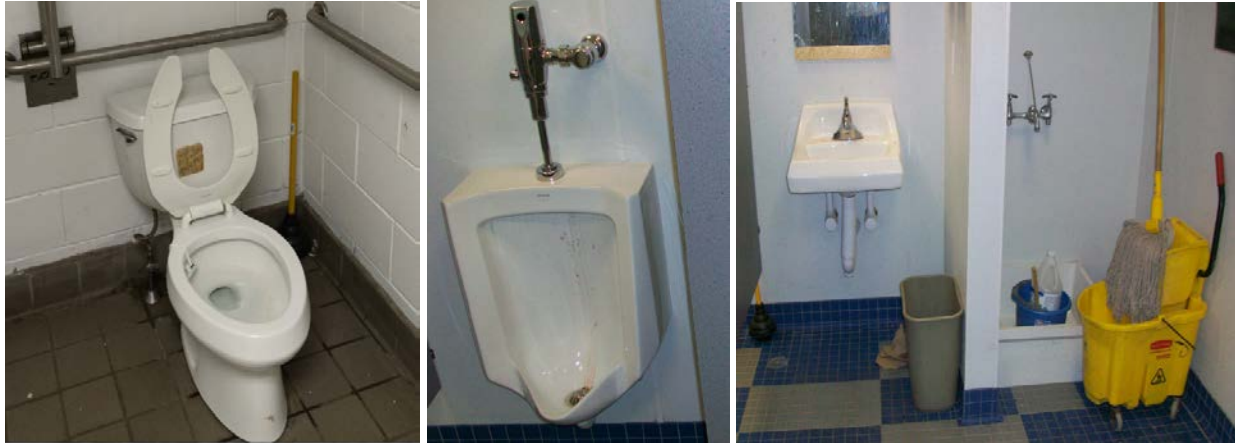
The facility is provided with a mixture of commercial and residential type fixtures. Bathrooms groups consist of tank type toilets, with lavatories, showers and floor drains. The drain piping arrangement for lavatories do not compliant with ADA standards as they interfere with clear knee space and some areas are not provided with insulation. Two kitchenettes with sinks are provided, and various water coolers are provided.

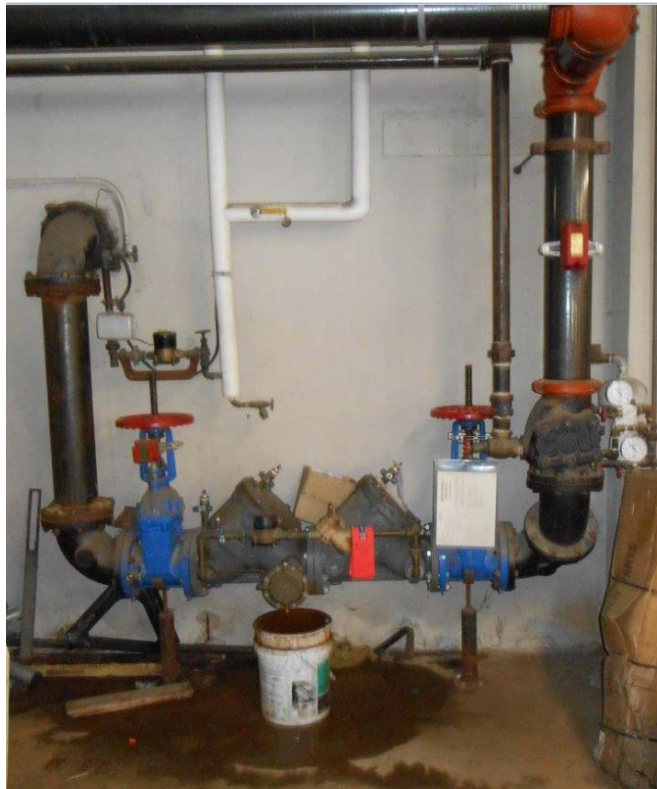
The facility is provided with a fully automatic fire sprinkler system with sprinkler coverage throughout the building. A 6" reduced pressure detector assembly backflow preventer, Febco model 825Y with by-pass meter, is provided to protect the municipal water supply from cross contamination. A large bucket is located below the backflow preventer to collect water due to constant dripping from the relief valve. The backflow preventer assembly has recently been inspected by Aquarion Water dated 4/15/15.

Based on conversation with the facility staff, the supply main became obstructed with rock and debris, it has subsequently been cleaned out, but the current internal condition of the piping and backflow preventer is unknown.

The backflow preventer constant dripping relief valve may be due to the normal operation of the valve due to DPW's standard operations (resulting in fluctuating water pressure) or debris

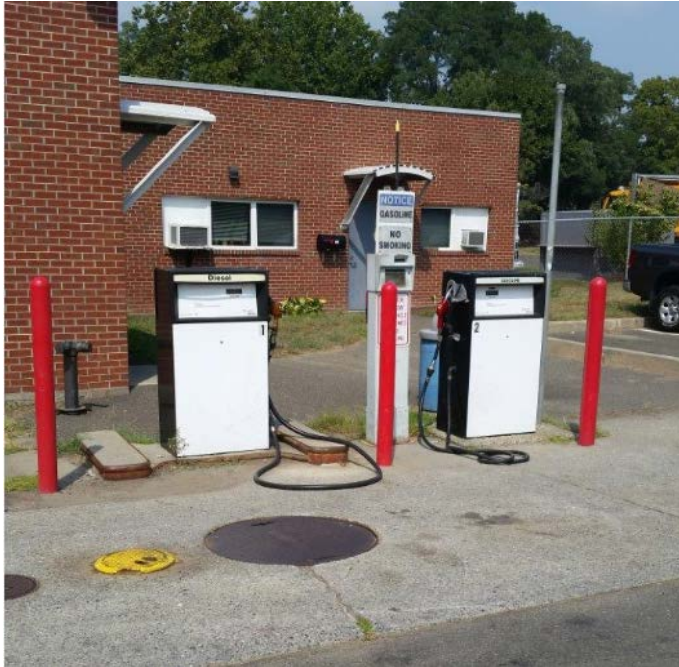
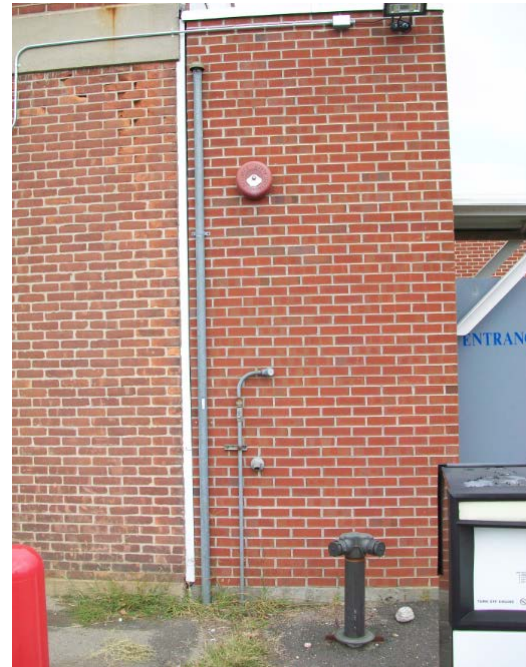
The existing factory tamper and flow switches have been disconnected from the backflow preventer and alarm valve assembly, the power and control wiring has been removed as well. The only notification appears to be an exterior water motor alarm (water powered mechanical alarm bell) with electric alarm pressure switch. This system would only be activated upon the fire department connecting to the double inlet (2-½" x 2-½" x 4") free standing Fire Department Connection (FDC) and charging the system with water via a pumper truck.

The water motor alarm and FDC are also located directly behind the existing gasoline and diesel pumping stations. The location of the Fire Department Connection (FDC) is a potential concern being in close proximity to the gas pumps (which can be considered a source of ignition). This scenario is a potential hazard to the first responder's safety and their ability to connect to the FDC with hoses, pumper truck, etc. to back feed the system as is their standard procedure.

It has been confirmed with the alarm check valve manufacturer (Reliable) that the use of the wet valve as a dry valve is not compliant with NFPA 13, the UL Listings and are not in accordance with the equipment installation requirements.

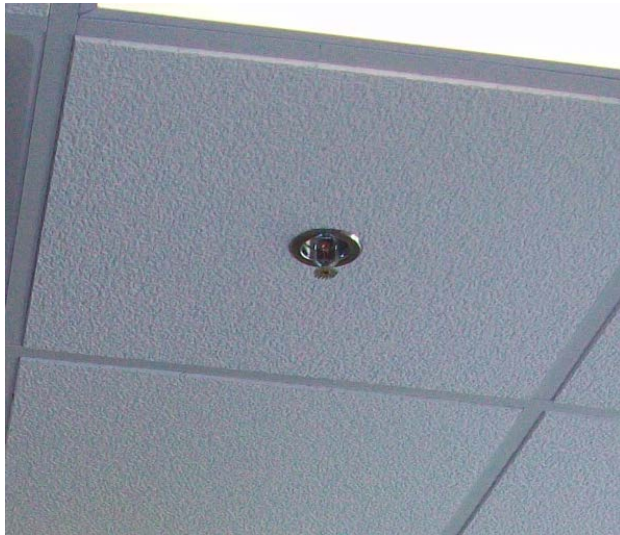
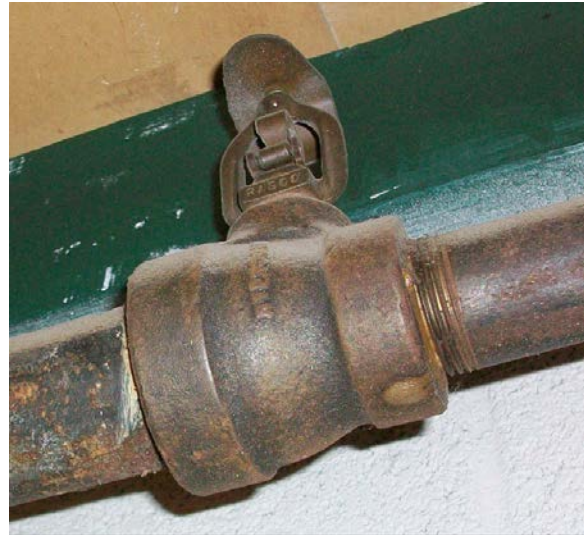
Exposed upright and pendent sprinkler heads are provided in areas without ceilings such as the garage bays and workshop areas. Semi-recessed sprinkler heads are provided in areas with ceilings such as offices, bathroom, kitchen, etc. The currently installed sprinkler heads are UL Listed for wet sprinkler systems not dry sprinkler systems.

Currently black steel piping with a combination of grooved mechanical or threaded joints and fittings are installed throughout the facility. This pipe material is appropriate for the original wet system, but is not appropriate for the converted dry system.

Due to the characteristic of a dry pipe sprinkler system's internal environment it is likely that the piping distribution system has areas of internal corrosion from water and moisture begin introduced during air pressurization and annual testing. The result is that water flow to the sprinkler heads can become obstructed in the smaller piping as oxidized material is removed or scoured off from the internal pipe surface during flow. This could compromise the life safety systems performance and ability to protect the occupants and property.
